Drawing Toluene into an ungrounded bucket

This case study investigates the factors resulting in an electrostatic ignition incident involving toluene, a prolific charge generator filling a metal bucket via gravity fed 0.75" metal piping.

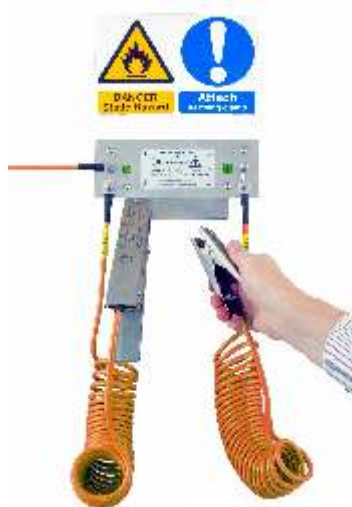
Static grounding clamps and cables like the ones highlighted in the image below, are ATEX/FM certified to prevent any physical impedances such as paint coatings, product deposits and rust ensuring a good electrical connection has been made to the equipment's base metal.

[ATEX/FM approved static grounding clamps with grounding station](#)

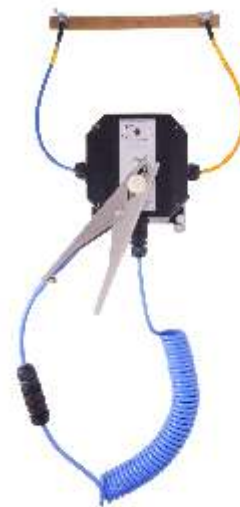
The Bond-Rite® REMOTE is a wall mounted static grounding device which encourages the operator to ground the equipment before the process starts. The ground loop monitoring system ensures a positive connection resistance of 10 ohms or less. Pulsing green LED indicators inform the operator with a simple GO/NO GO instruction that the process is ok to start.

[Bond-Rite® REMOTE - Continuous Ground Loop Monitoring with visual indication.](#)
